# Providence College Tree Inventory & Management Plan | 2015

Submitted by  
**The Bartlett  
Inventory Solutions  
Team**

In April, 2015, the Bartlett Inventory Solutions Team from Bartlett Tree Experts conducted an inventory of trees on the Providence College campus. We identified 1,489 trees that included 82 species. The attributes that we collected include tree latitude and longitude, size, age and condition class, and a visual assessment of tree structure, health, and **vigor**.

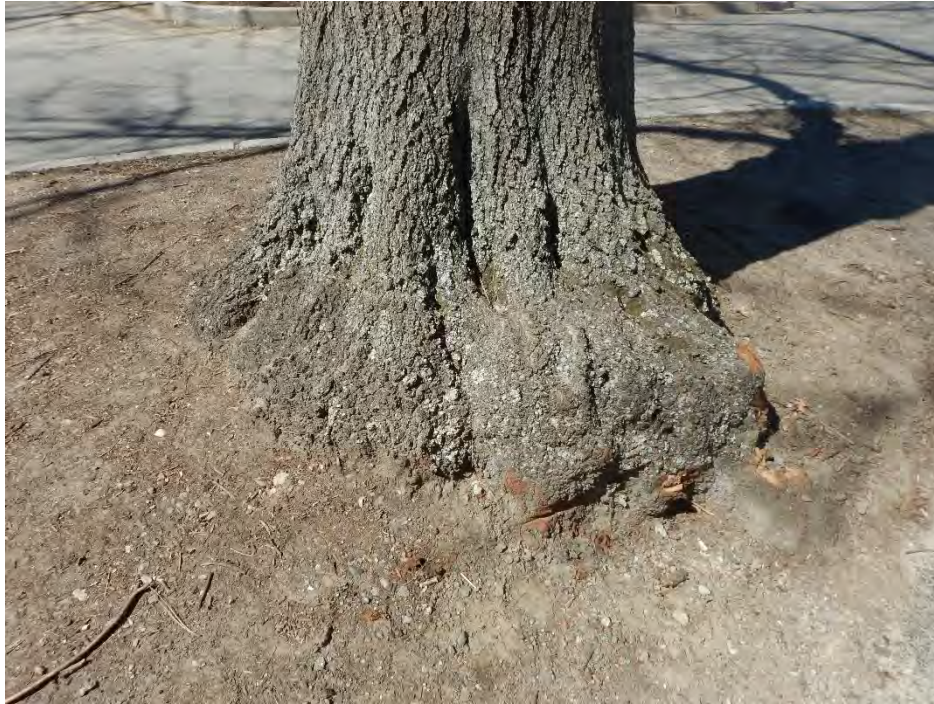
**Figure 4: Tree #281 recommended for Root Invigoration™ due to compaction of the root zone.**

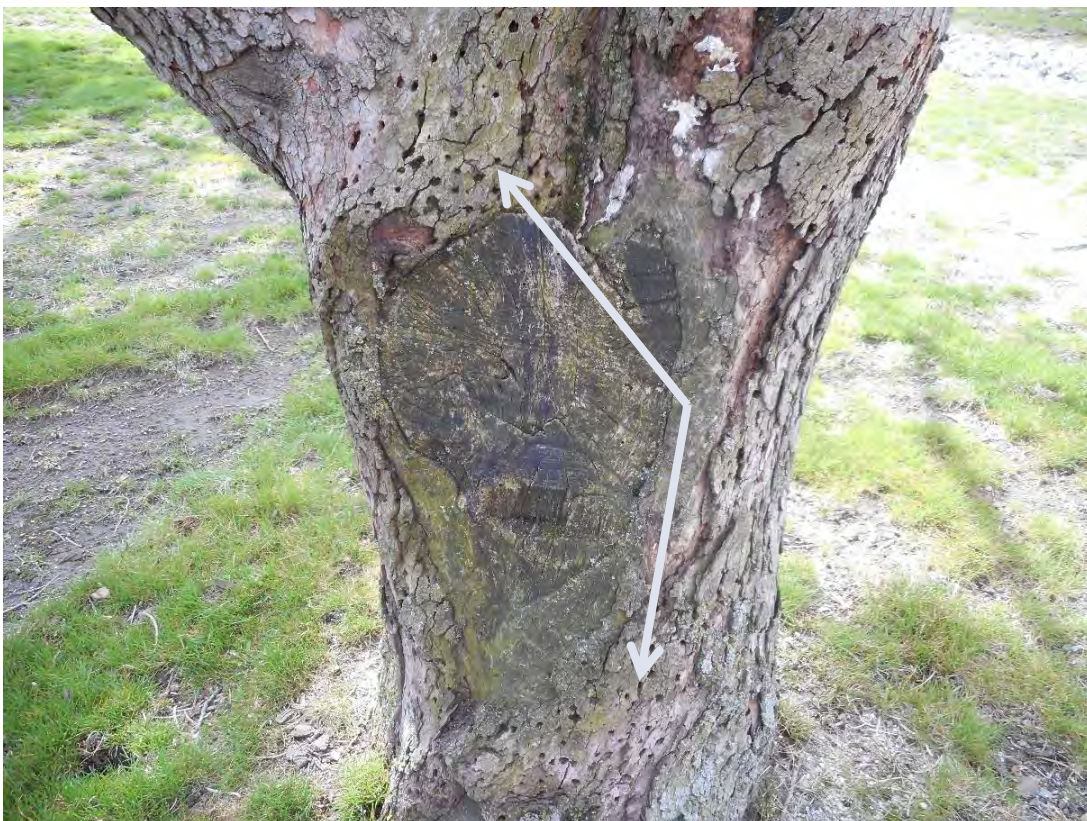
**Figure 13 : Tree #574 with borer damage.**

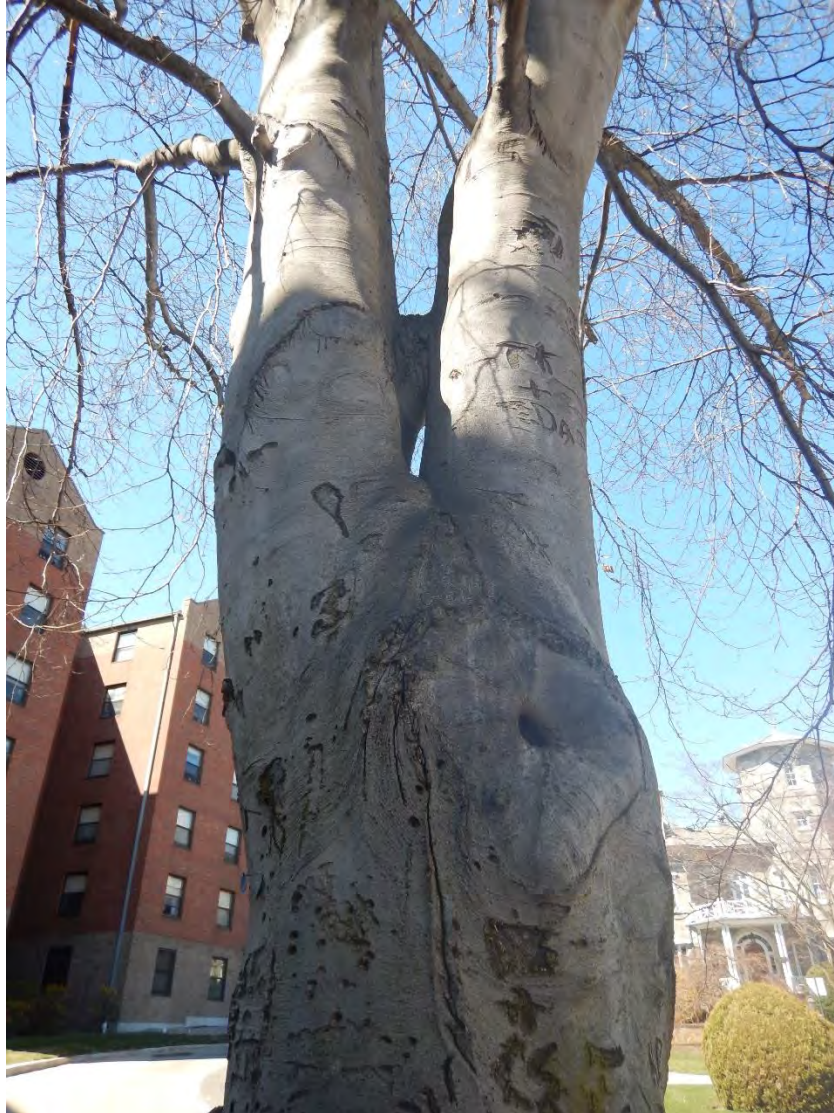
**Figure 22: Tree #344 recommended for cabling due to the presence of co-dominant leaders.**

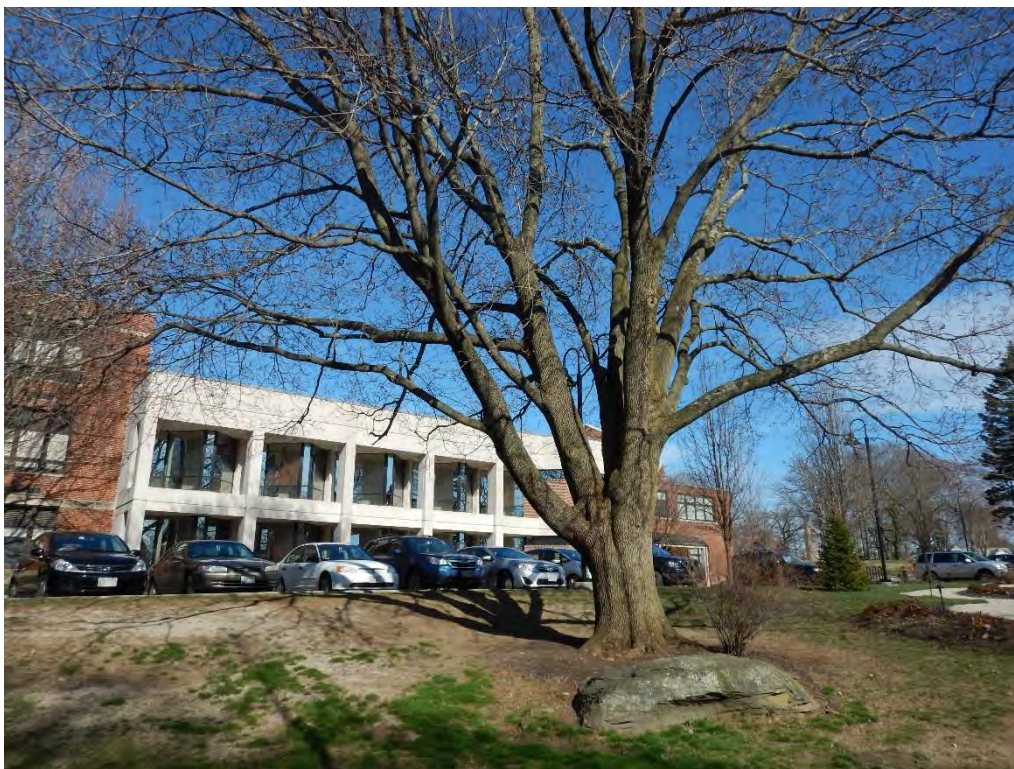
**Figure 23: Tree #472 recommended for removal due to multiple defects, including co-dominant leaders, stem cavities and overextended branches.**

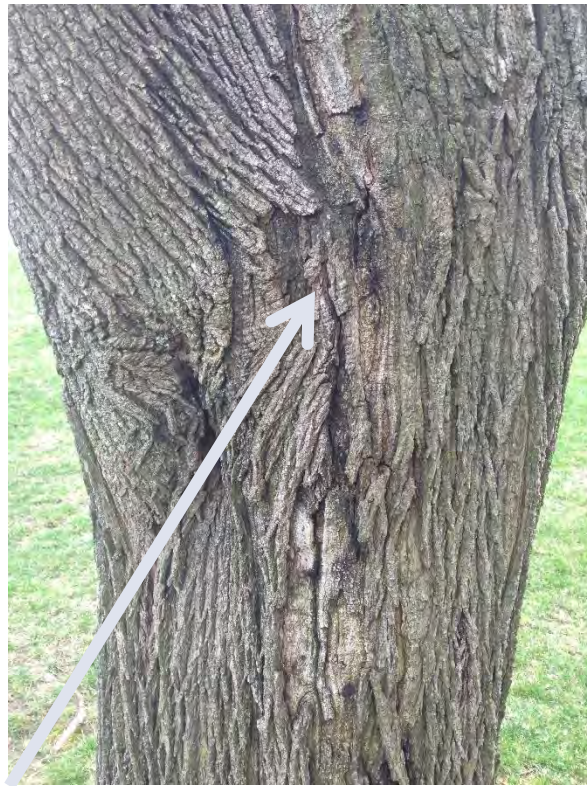
**Figure 24: Included bark on Tree #108 necessitates a Level 3 *advanced assessment* to more thoroughly assess risk of failure.**

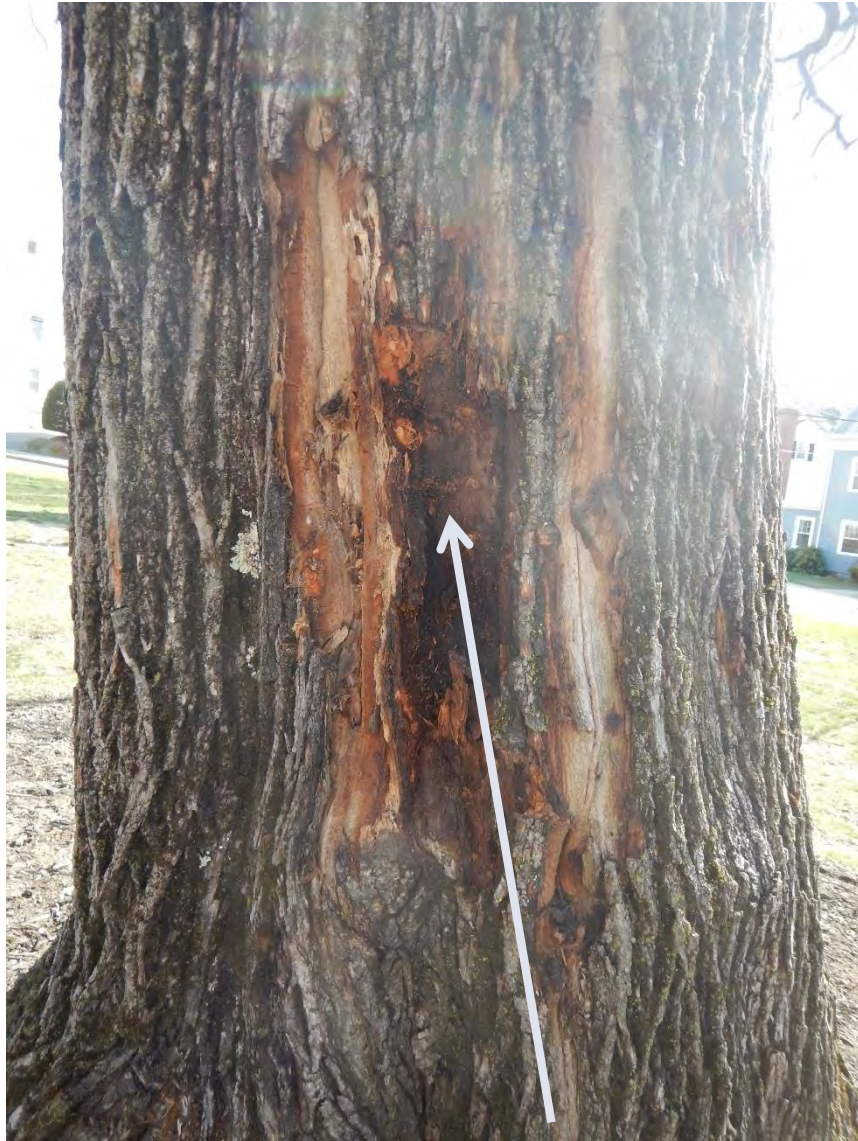
**Figure 26: Tree #470 exhibiting a wound on the stem.**
