# Providence College Tree Inventory & Management Plan | 2015

Submitted by  
**The Bartlett  
Inventory Solutions  
Team**

In April, 2015, the Bartlett Inventory Solutions Team from Bartlett Tree Experts conducted an inventory of trees on the Providence College campus. We identified 1,489 trees that included 82 species. The attributes that we collected include tree latitude and longitude, size, age and condition class, and a visual assessment of tree structure, health, and **vigor**.

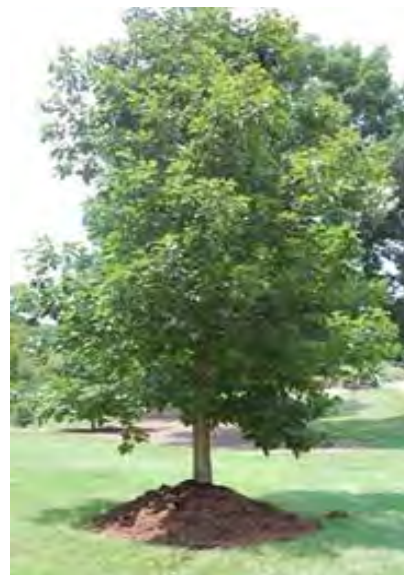
**Figure 8:** Example of improper mulch application, known as “volcano mulch”.

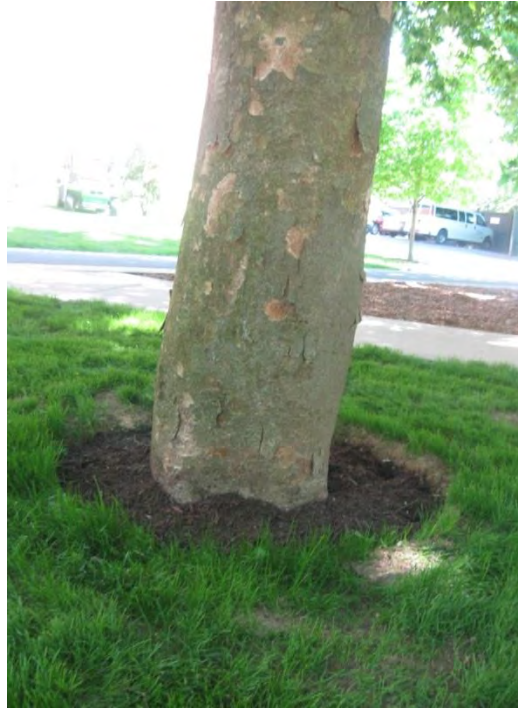
Excavating the root collar is necessary for trees whose buttress roots are covered by excess soil or mulch. Buried root collars can contribute to tree health problems, including girdling roots, basal cankers, and masking root and lower stem decay.

**Figure 9: Example of a buried root collar.**

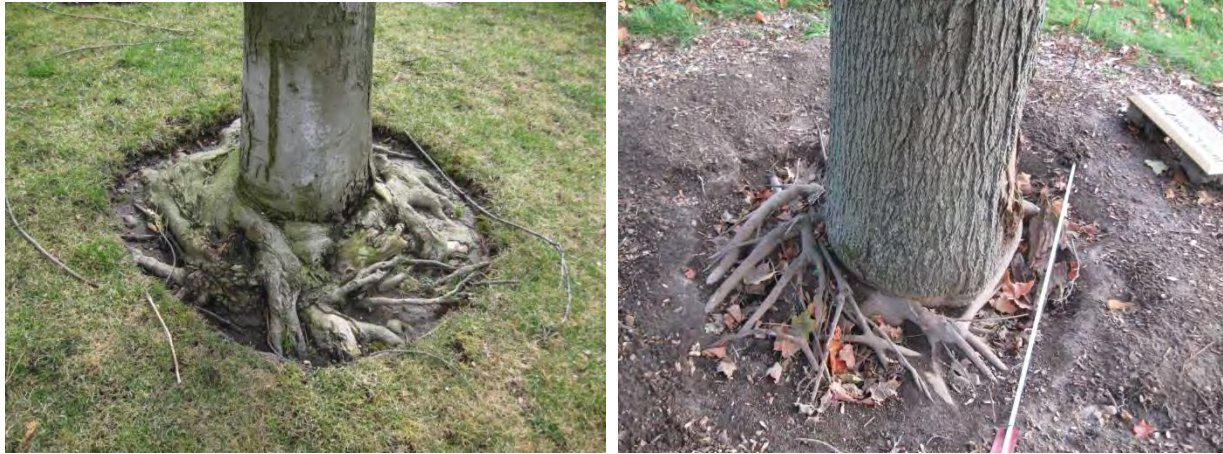
Girdling roots (Figure 11) restrict water and nutrient movement throughout the tree. If left untreated they can cause the tree to decline, fail (Figure 12), and eventually die in severe cases. Girdling roots should be removed as soon as possible, unless removal will significantly impact the condition of the tree. In some cases, the presence of significant or severe girdling roots may cause the tree to be recommended for removal.

**Figure 11: Examples of girdling roots.**

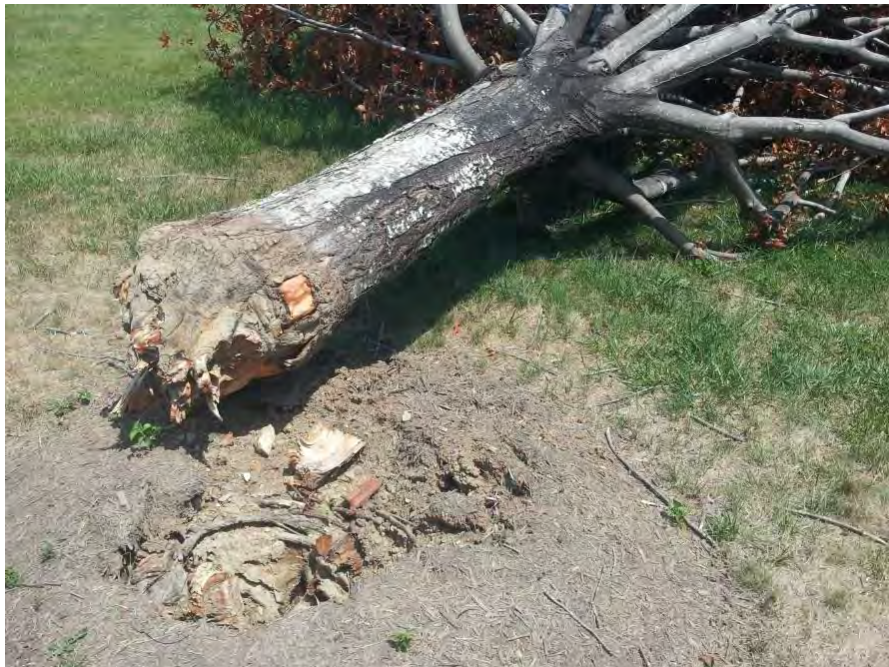
**Figure 12: Example of tree failure from girdling roots.**

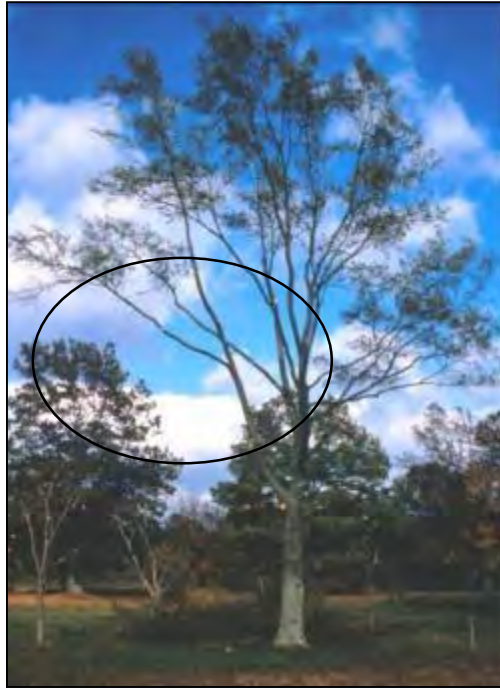
- Lion’s Tailing – pruning that removes interior branches along the stem and scaffold branches. This encourages poor branch taper, poor wind load distribution, and risk of branch failure. It also deprives the tree of foliage it needs to produce **photosynthates**. See Figure 14.

**Figure 14: Example of Lion's tailing.**

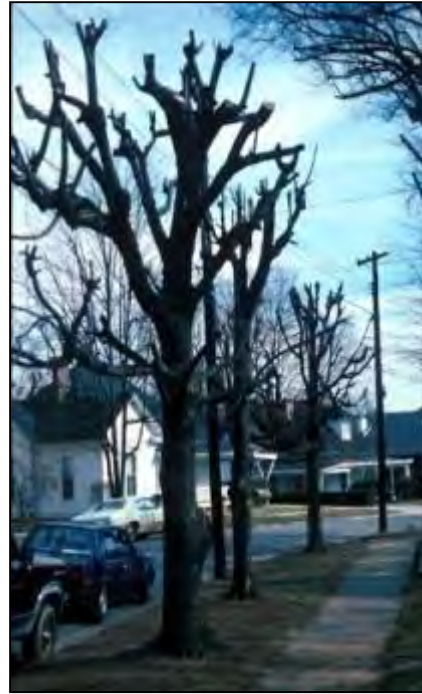
- Topping – pruning cuts that reduce a tree’s size by using heading cuts that shorten branches to a predetermined size. Topping substantially reduces the functional benefits a tree is capable of providing and predisposes trees to structural defects that can contribute to failures in the future. It also reduces the value of the trees substantially and deprives the tree of adequate foliage. See Figure 15.

**Figure 15: Examples of topping**

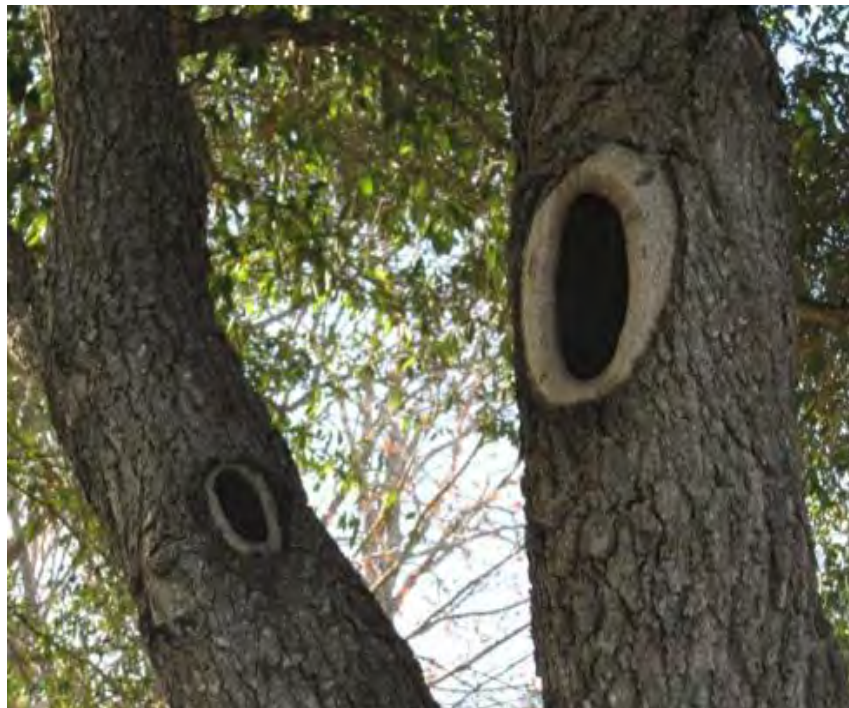
- Flush Cuts – pruning cut through the **branch collar**, flush against the trunk or parent stem, causing unnecessary injury. See Figure 16.
- Using Climbing Spikes Inappropriately – Using climbing spikes on a healthy tree, for example, wounds healthy stem tissues and can lead to infection by fungal pathogens.

**Figure 16: Examples of flush cuts**

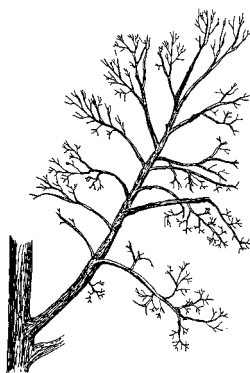
*Correct pruning*

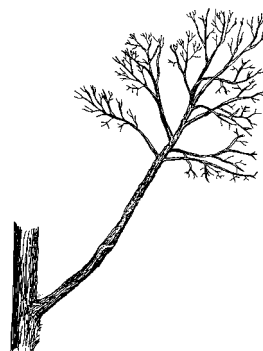
*Improper pruning*

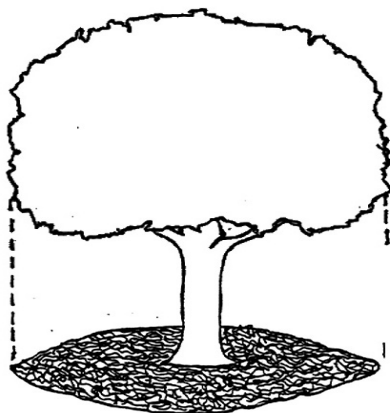
*Figure 1. Mulch should be applied from the trunk to the dripline.*

2. Mulch should be applied from the dripline to the trunk (Figure 1). If this

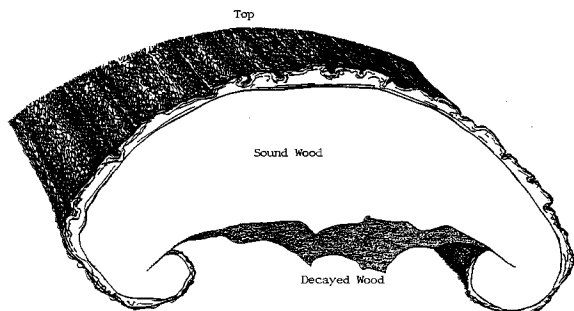
Root decay is difficult to assess since it starts on the lower section of the root and works its way upward. The most visible section of the root shows the least amount of symptoms. When root decay is present in the buttress or flare roots it is usually

*Typical pattern of root decay, starting from the lower side working upward*
